**Section 5**  
**CALIBRATING EQUIPMENT**  
**L Series**

## SECTION 5. CALIBRATING EQUIPMENT

### → MODEL LM SERIES FIELD CHANGE NO. 1

#### ADDITION OF ADJUSTMENT LEVER FOR CORRECTOR DIAL

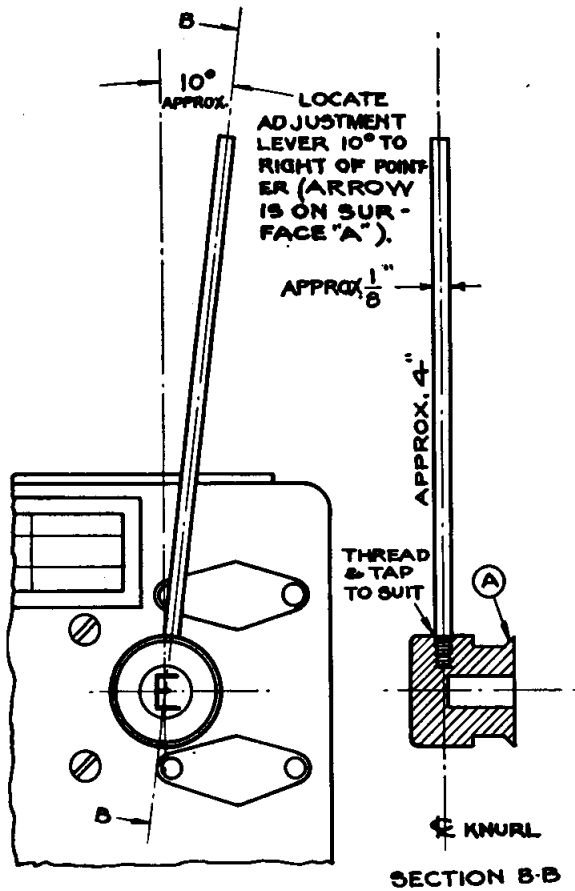
Figure 1.—Adjustment lever for corrector dial.

*Equipment affected.*—All models of LM series.

*Purpose.*—To facilitate the moving of the corrector knob in small increments.

*Action required.*—The corrector knob should be removed from the equipment and drilled and tapped as shown in Figure 1. A brass or steel rod having the approximate dimensions shown in the figure should be threaded at one end. The adjustment lever is offset about 10° in order that the dial be visible when the corrector knob is rotated to its full counter-clockwise position.

*General.*—This change is within the capacity of the ship's force. Record of this change should be made on the ship's "Radio Equipment Log" NAVSHIPS 900,039. Completion of this change should be reported on the NBS-383 failure report form. 6/1/46

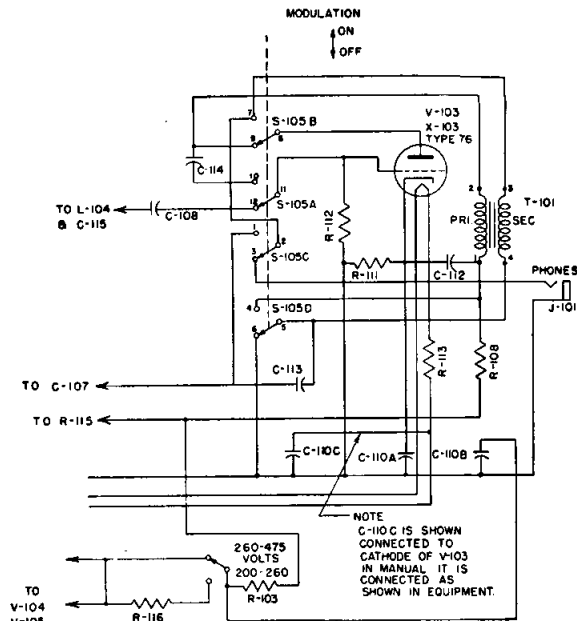
FIGURE 1.—Schematic diagram of the LM-18 frequency meter.

The Bureau has been informed of two errors which appear in the LM-18 instruction book NAVSHIPS 900,002. The first one is on page 17, in section V (2d) under the column V-103, which indicates the pin markings and voltages of tube V-103. The pin numbers for the filaments are incorrect, filament 1. should read 6.8AC (5) and filament 2. should read 0.0 (1). The second error appears on the schematic wiring diagram figure 20. C-110C is shown connected in parallel with C-110A while it should be connected as shown on the corrected wiring diagram given here on figure 1. 8/1/46 ←
