SECTION 6. COMBINATION TRANSMITTING AND RECEIVING EQUIPMENT

MODEL MN SERIES TROUBLE SHOOTING NOTES

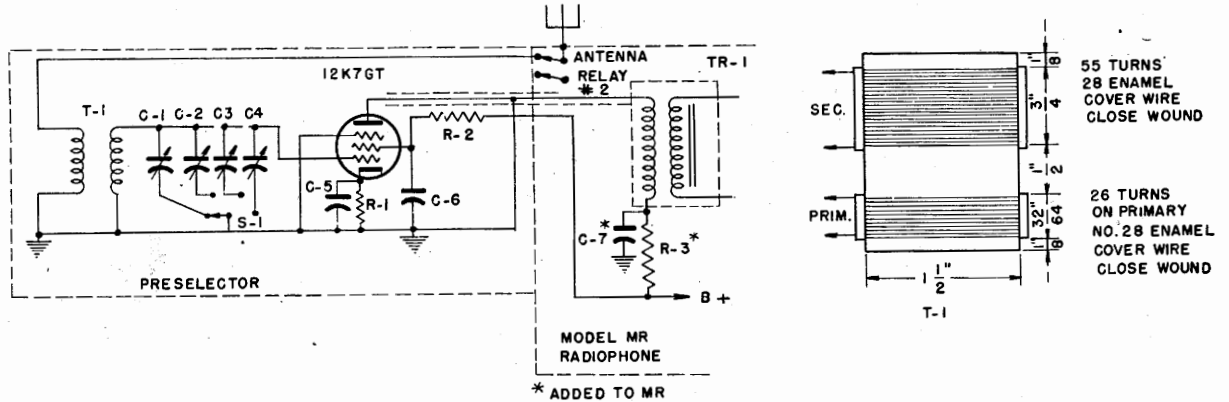
FIGURE 1.—Schematic of preselector for model MR radiophone.

suitable preselector which prevents radiation of the local oscillator. When the preselector is incorporated in the equipment, the model MR may be used aboard ship. Figure 1 is the schematic diagram of the preselector. Figures 2 through 5 inclusive show constructional views of the preselector.

Switch S-1 provides for switching for the four fixed channels. The tuning condensers C-1, C-2, C-3, and C-4 are tuned on switch positions 1, 2, 3, and 4 respectively for any frequency in the range of the equipment. The tuning condensers have been so connected that the tuning of each channel is independent of all others. Adjustment

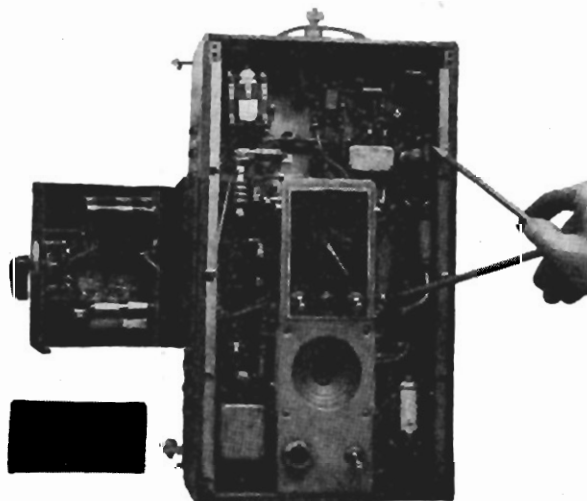
FIGURE 2.—Front view of MR with cover removed, showing connections to preselector.

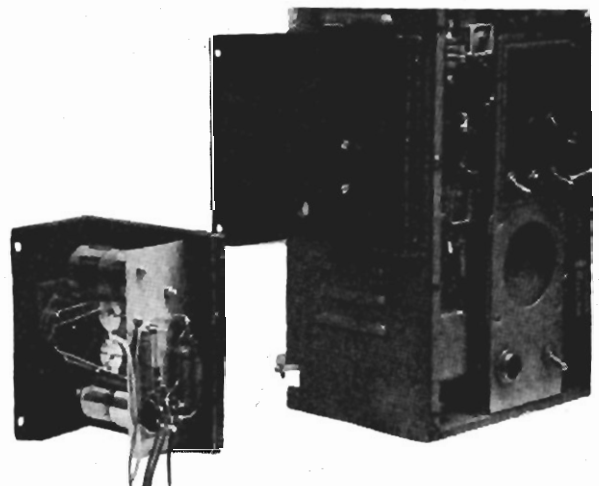
FIGURE 3.—Open view of preselector showing tube base connections.

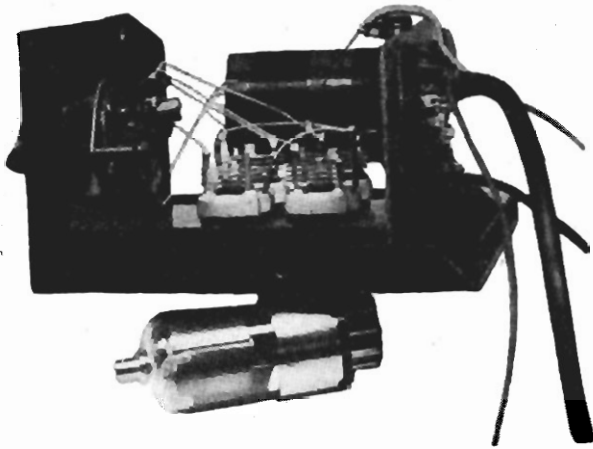
FIGURE 4.—Close-up of preselector with tube removed.

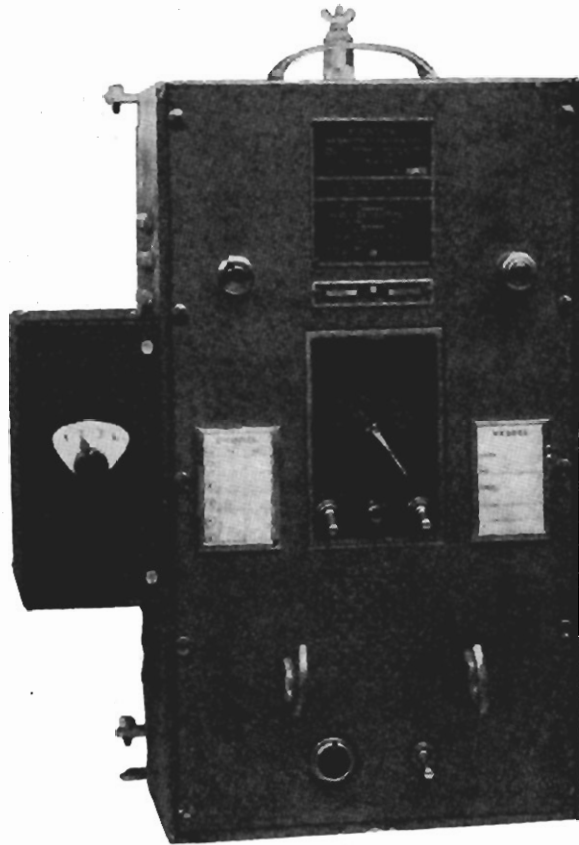
FIGURE 5.—Front view of MR.

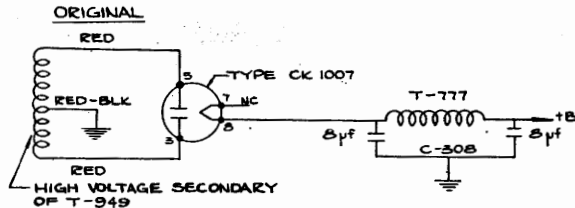
FIGURE 1.—Original socket connections.

In locations where there is considerable a-c line voltage fluctuation, it has been found that the life of the type CK 1007 gaseous rectifier tube in the model MS power supply is short.

The operation of the equipment may be improved by substituting a type 5U4G rectifier tube for the CK 1007 tube. Power is supplied to the filament of the 5U4G from a 110- to 5-volt step-down filament transformer. The secondary of the transformer should be capable of supplying 3 amperes continuously. Use of the 5U4G tube will require rearranging the socket connections as shown in Figures 1 and 2. Socket pin connections for the 5U4G are shown in Figure 3.

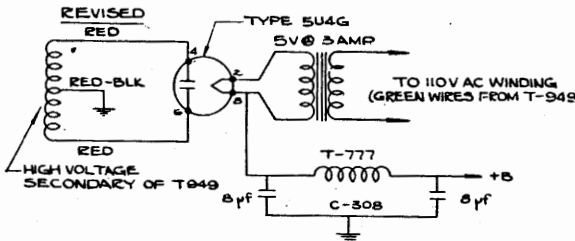
FIGURE 2.—Revised socket connections.

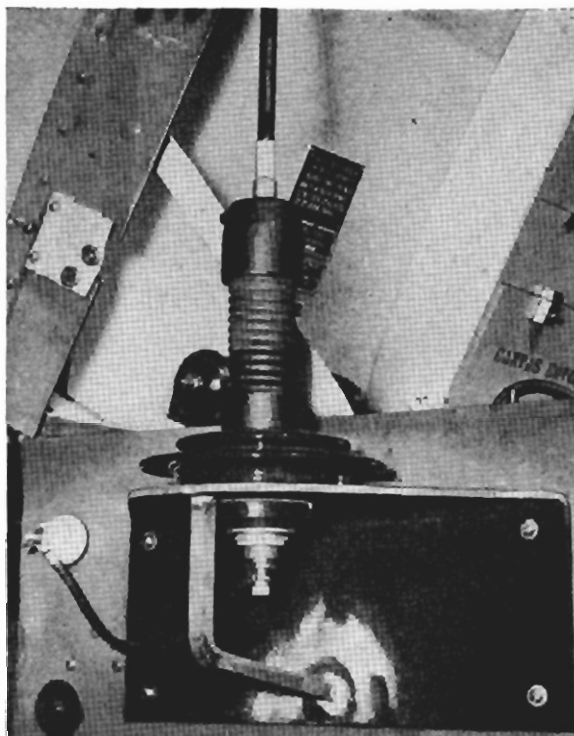
The necessity for communication with aircraft 5 and 10 miles distant from the signal officer requires more radiation than is obtainable from the whip antennas furnished with model MAM equipments.

FIGURE 1.—Method of mounting a type MP-37 whip assembly on an MAM equipment.

Experiments indicate that by supplanting the whip antenna furnished with a type BG-56A whip, or equivalent, the needed performance is obtained without interfering with other equipments at adjacent fields.

The photograph of Figure 1 shows a close-up of the method employed in mounting a complete type MP-37 whip assembly, including the spring base employed to prevent the whip from snapping off.

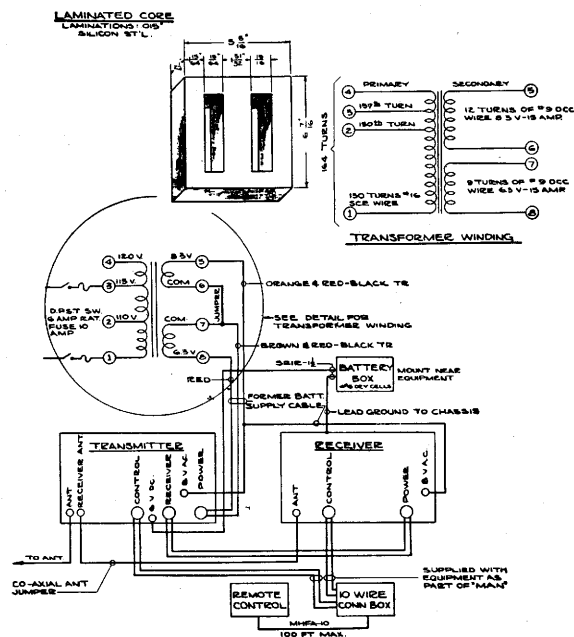
FIGURE 1.—Details of the transformer and interconnections needed for the modification.

A 10-wire connection box must be mounted within 3 feet of the transmitter and receiver (see Fig. 1). This connection box is to splice

the leads coming from the MAN equipment and the remote head if one is used. When wiring the remote, note that the numbers attached to the wires from the equipment correspond to numbers on the terminal board in the remote control head. Do not connect wire #1 to pin #1 on the plug, that is, pins on plugs do not correspond to numbers taped on wires.

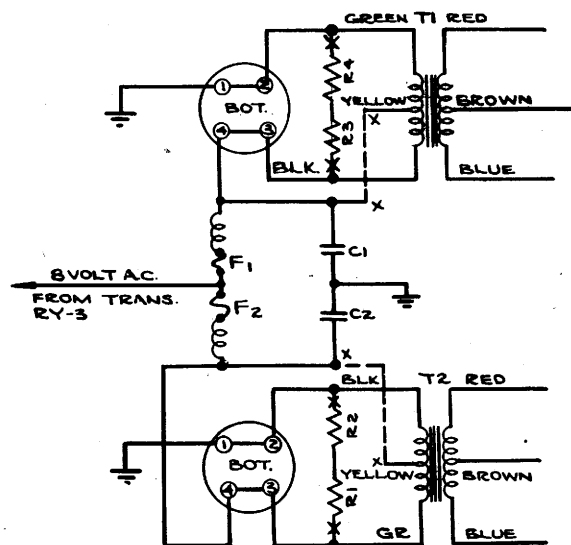
FIGURE 2.—FMT-25VW transmitter vibrator power unit modification.

- (1) Remove vibrators.
- (2) Remove R_1 , R_2 , R_3 , and R_4 .
- (3) Connect jumpers from pin #1 to pin #2, and from pin #3 to pin #4 on both vibrator sockets.

- (4) Disconnect the center tap of power transformer T-1 (two solid wires in yellow spaghetti). Solder together the two wires and tape up to insulate from the chassis. This connects the two halves of the primary in series. Power transformer T-2 is modified in the same manner.

- (5) Disconnect and tape 6-volt power supply lead (copper rope). Run new lead from this point to 8-volt a-c supply.

- (6) Replace 50-amp. main power fuse with a 15-amp. fuse.

- (7) Replace 20-amp. receiver fuse with a 10-amp. fuse.

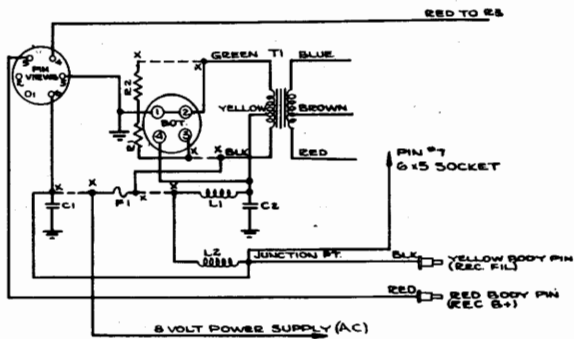
FIGURE 3.—FMR-13V receiver vibrator power unit modification.

- (1) Remove vibrators.
- (2) Remove R_1 and R_2 .
- (3) Disconnect and solder together center-tap leads (yellow) on primary of T₁.
- (4) Connect pins #1 and #2 on vibrator socket together.

(5) Remove wires as indicated by dotted lines and "X".

(6) Connect 8-volt a-c supply to F_1 ; remove black wire coming from transformer primary from vibrator pin #3, and connect it to remaining side of F_1 .

(7) Run jumper, from the junction of pin #7 of 6X5 socket and yellow pin connector, to pin #6 of power plug.

(8) Rec. tube 6K6 by-pass condenser C-73 is changed from 0.02 to 0.002 mfd.

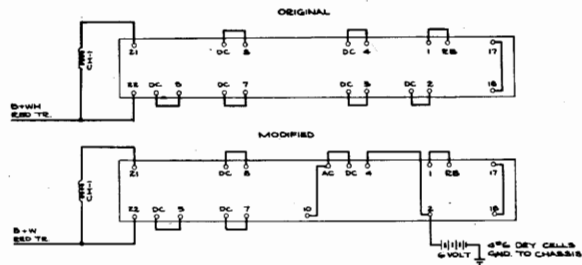
FIGURE 4.—Transmitter terminal strip modification.

(1) Remove jumper between DC and 4. Connect DC to AC. Extend jumper to lug 10.

(2) Connect lug 4 to lug 2.

(3) Make up pair 24-inch leads. Connect one to lug 2, other to chassis. Connect free ends to 6-volt battery, made up of four no. 6 dry cells in series—dry cells to be placed in compartments inside equipment case.

(4) Remove jumpers between lugs DC to 3, and DC to 2. ←
