ELECTRON

NOVEMBER 1950

NavShips 900,100

In this Issue....
SWIMMER OPERATED
ECHO SOUNDING
EQUIPMENT

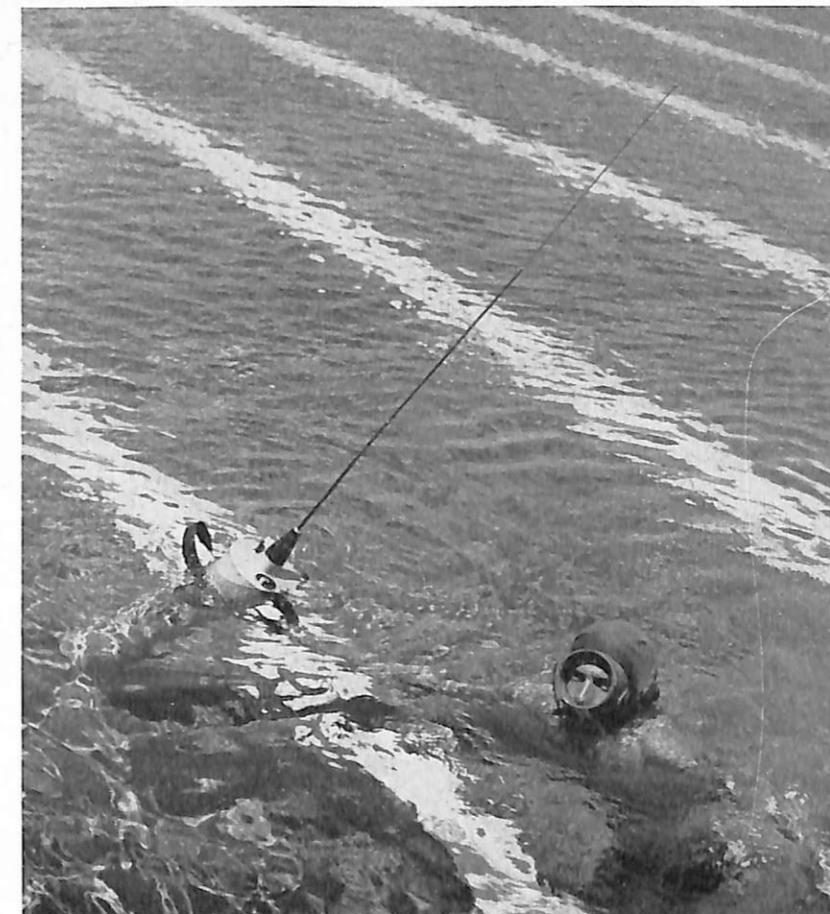
FIGURE 3—Swimmer towing STAR buoy.

The STAR system is a remotely indicating echo sounder in combination with a two-way radio communication system. The buoy, which contains an echo sounder and a two-way radiotelephone, is towed by a swimmer, as shown in Figure 3. The STAR shipboard station consists of a two-way radiotelephone, an indicator control unit, and a CRO. The buoy continuously transmits sonar depth information to the ship, where it is displayed on the CRO. With no interruption to the display of depth information, the swimmer may listen for calls from the shipboard operator or talk to him at will. The entire operation is accomplished on a single radio channel.

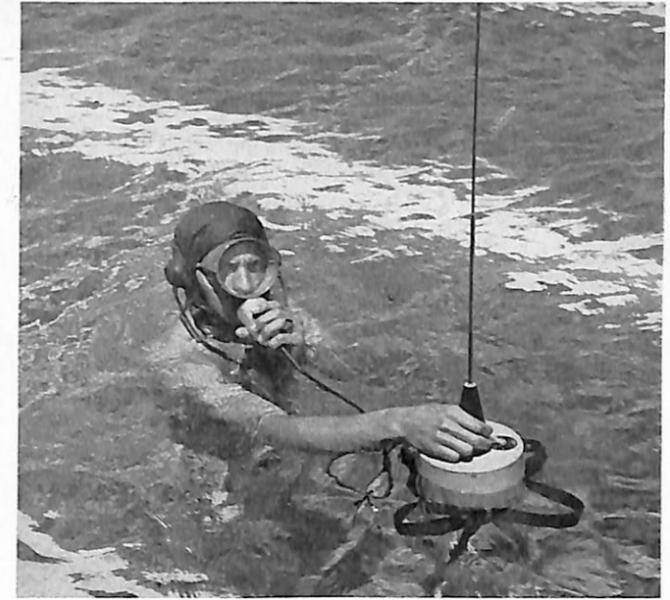
The STAR buoy will measure water depths from 5 to 80 ft. and has a line-of-sight radio range of 7000 yd. To put this buoy in operation, the swimmer extends the antenna, releases the transducer, and rotates a selector switch located on the top surface of the body. Refer to Figure 6. This switch has three positions, OFF, ON, and TALK ONLY; and was designed to give positive positioning even when operated with gloved hands. When the switch is in the ON position, swimmer-to-ship or ship-to-swimmer communication may be conducted. Simultaneously—and without interference—sonar depth information will be continuously transmitted. When the switch is in the TALK ONLY position, radio silence may be maintained at the buoy; the swimmer may listen continuously for communication from the shipboard operator and break silence only when replying. In the TALK ONLY position the sonar transmission is inoperative.

FIGURE 6—Swimmer sets switch on top of buoy and uses waterproof microphone to communicate with ship.
