BUSHIPS

# ELECTRON

**SHIPBOARD  
UHF  
CAN  
WORK**

by  
H. W. WOLFF,  
U. S. Navy Electronics Laboratory  
San Diego, California

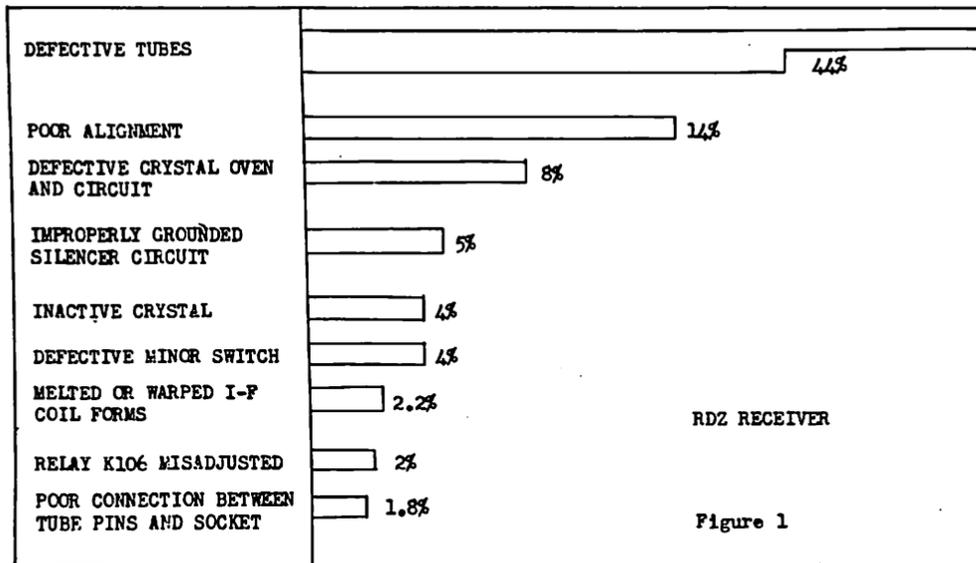
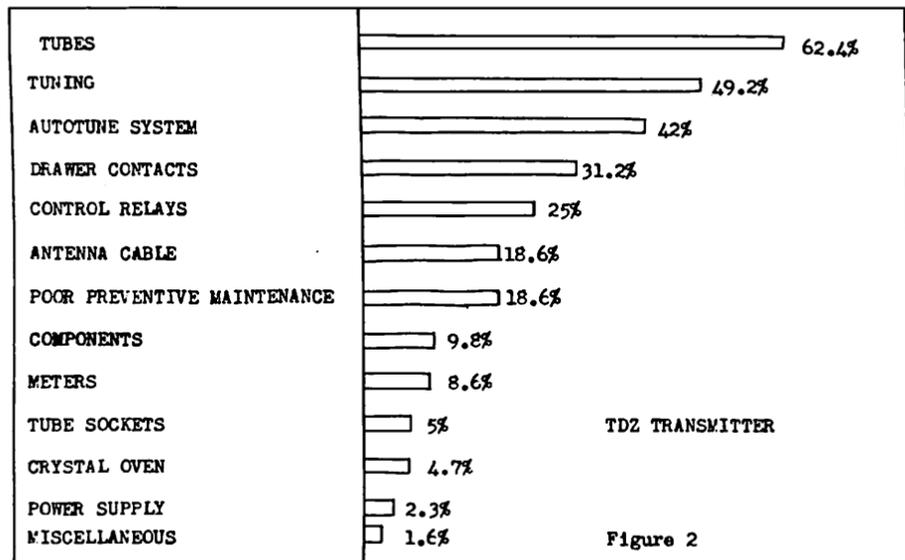
FIGURES 1 and 2—Percentage of system failures caused by items indicated. (Based on 144 reports of troubles in systems).

Other troubles with the RDZ are the same that would be expected in any receiver. Figure 1 shows how a large group of failures found aboard ships fell into a few classes. From this simple chart you can see that it is usually not necessary to exert too much effort to keep your RDZ going.

Figure 2 shows the story for the TDZ. This set is a complicated piece of gear, and a lot of things can happen to it. However, *with a few precautions*, good service can be had from it. The percentages on this chart add to more than 100% since many equipments had more than one fault, and all faults are listed. The first three, and largest, of the items listed can be largely avoided *if you are careful*, and follow these instructions:

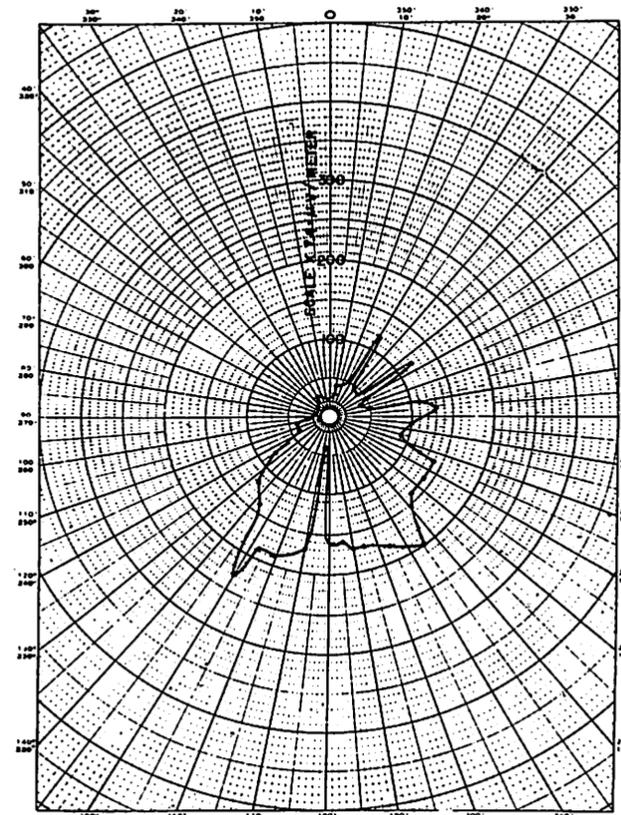
FIGURE 3—Pattern of USS Peregrine Starboard No. 2 Antenna at 328.2 Mc.

However, *having* a good antenna is not enough. It must be mounted in a location that permits it to radiate uniformly. Take a look at Figure 3. Can you imagine yourself aboard the *Peregrine*, and trying to communicate with a ship lying 10 miles off your port bow? Or if you are in column, how about trying to raise the lead ship? Not much chance if you use Starboard Antenna No. 2, is there? The same kind of a situation exists in the *Adirondack*, Figure 4. Here it is not quite so bad, except where the radiation goes to zero at 20° and 105°.

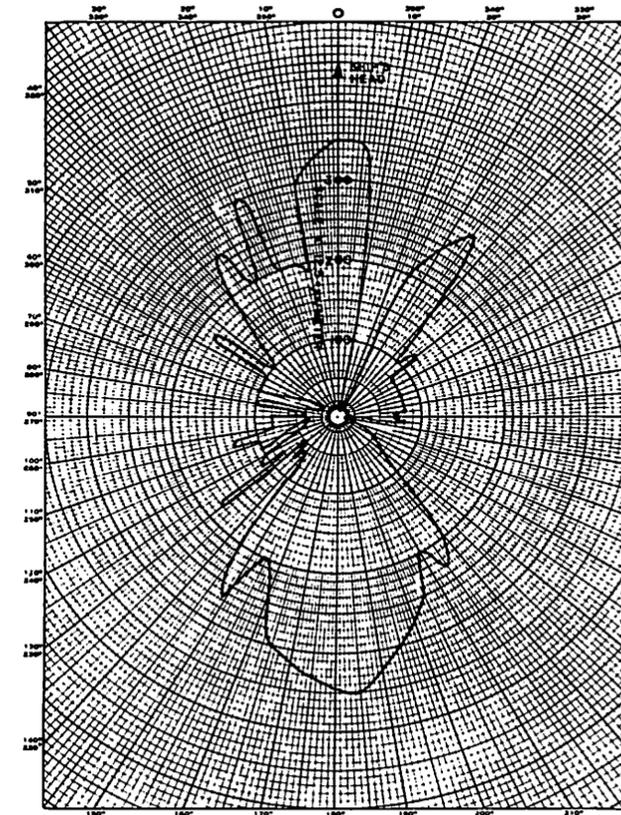
FIGURE 4—Pattern of USS Adirondack Antenna No. 5 (Port TDZ From Radio IV) at 285.0 Mc.

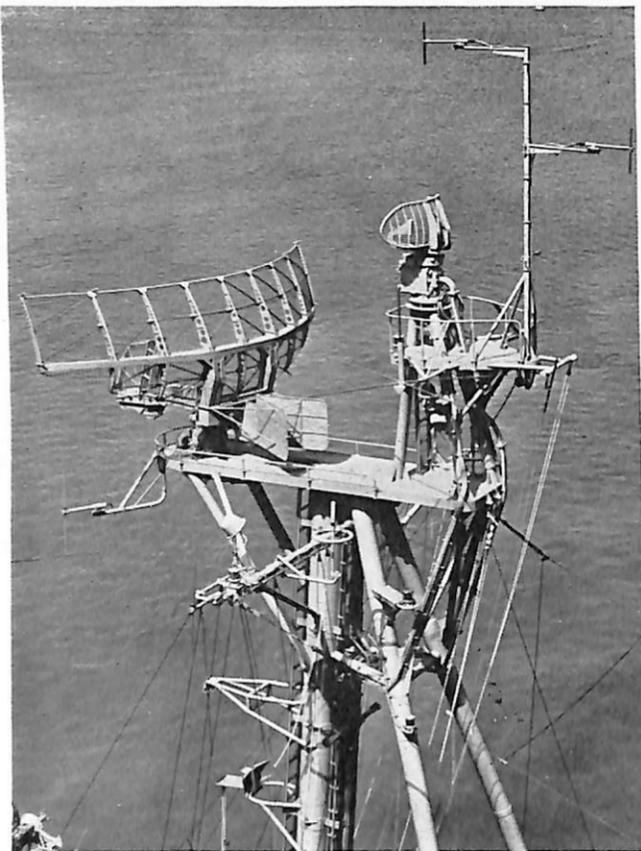
FIGURE 5—Installation on the *USS Hamner (DD-718)*.

Unfortunately this condition is found on most ships in the fleet. This is probably one of the major faults in the system, and one which has made many people dislike it. In many ships this condition is being alleviated by relocating u-h-f antennas so that they can be in the clear. Figures 5 and 6 are photographs of u-h-f

antenna installations on the *Wiltsie* and the *Hamner*. Here, mast extensions permit the u-h-f antennas to look over the top radar, yet they do not spoil the radar display. Figures 7 and 8 reveal what a difference this type of installation means in antenna patterns. These patterns are not directly comparable with those of Figures 5 and 6, since decibels were used instead of a linear microvolt scale. However, it is easily seen that no deep minima exist.

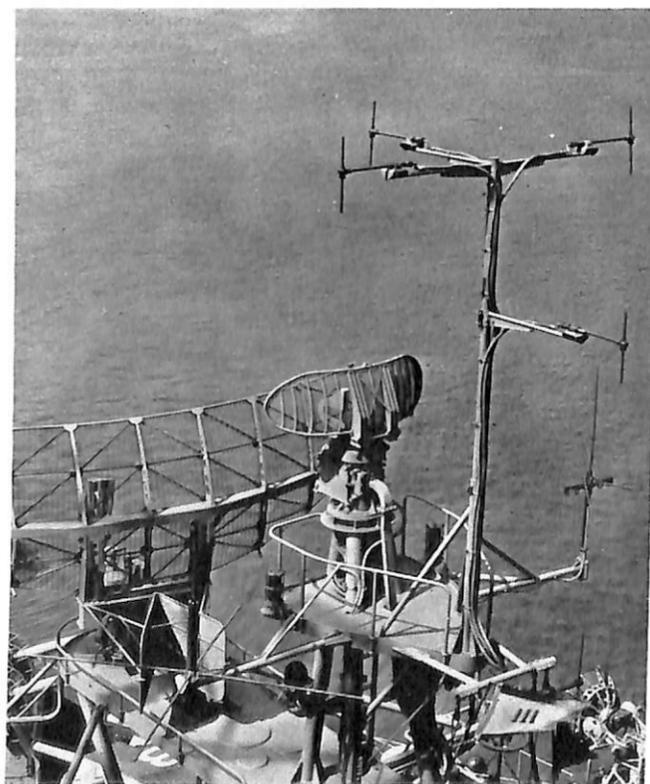
FIGURE 6—Installation on the *USS Wiltsie (DD-716)*.

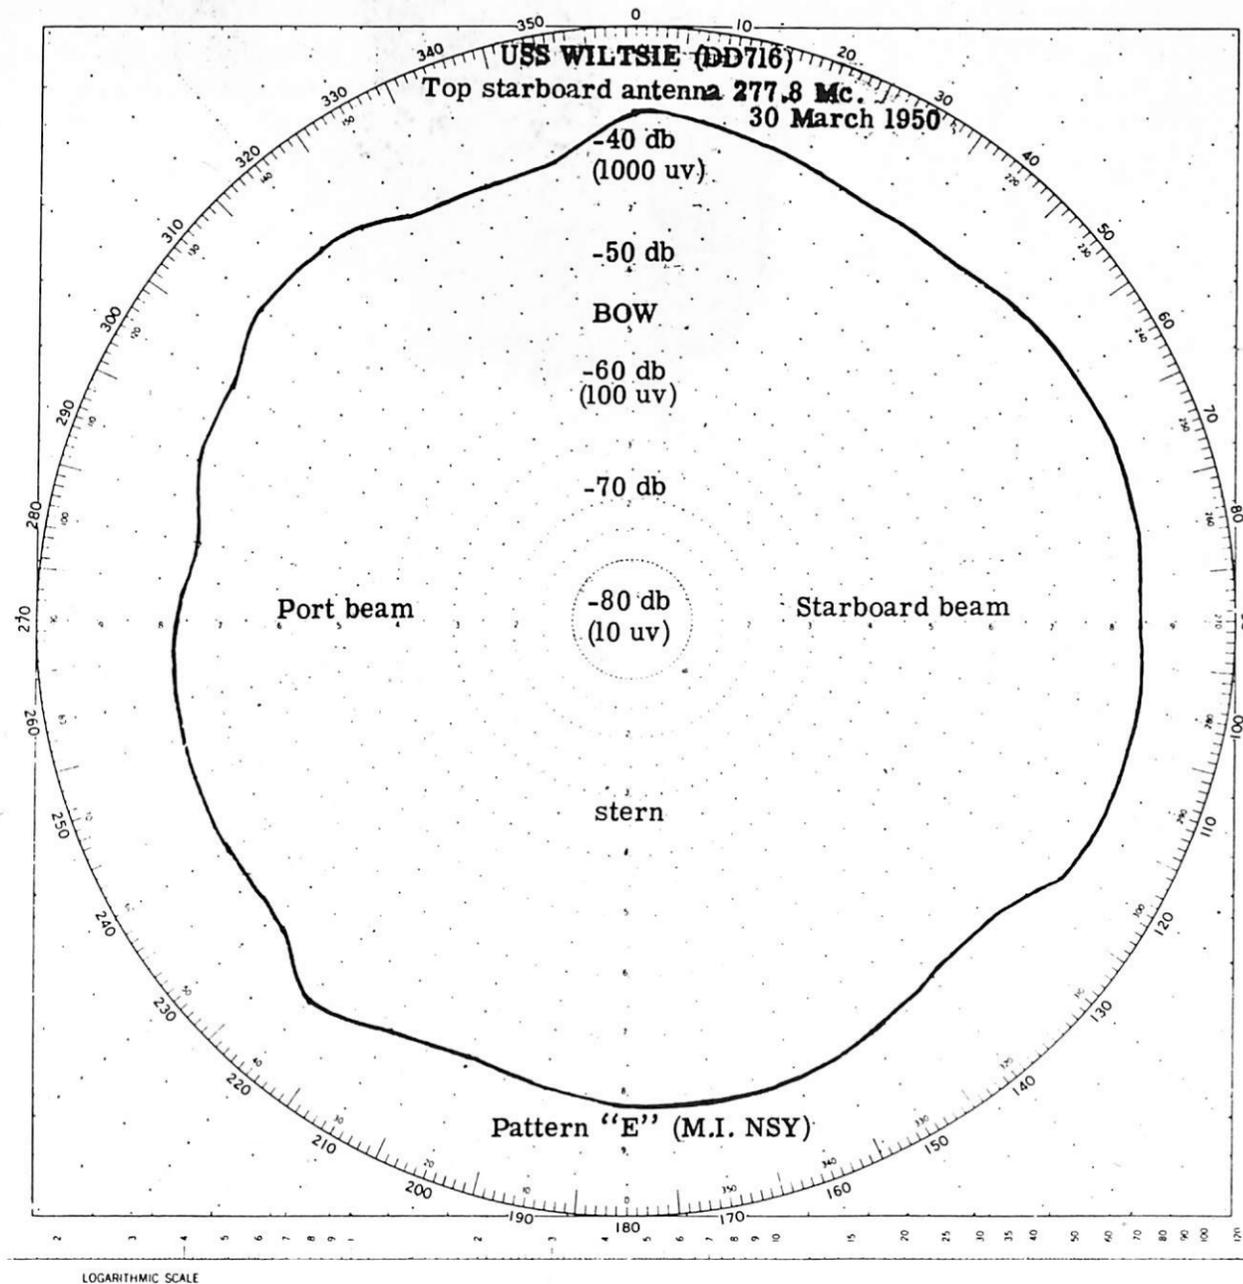
FIGURE 7—Antenna pattern from *USS Wiltsie (DD-716)*, top, starboard antenna, 277.8 Mc.

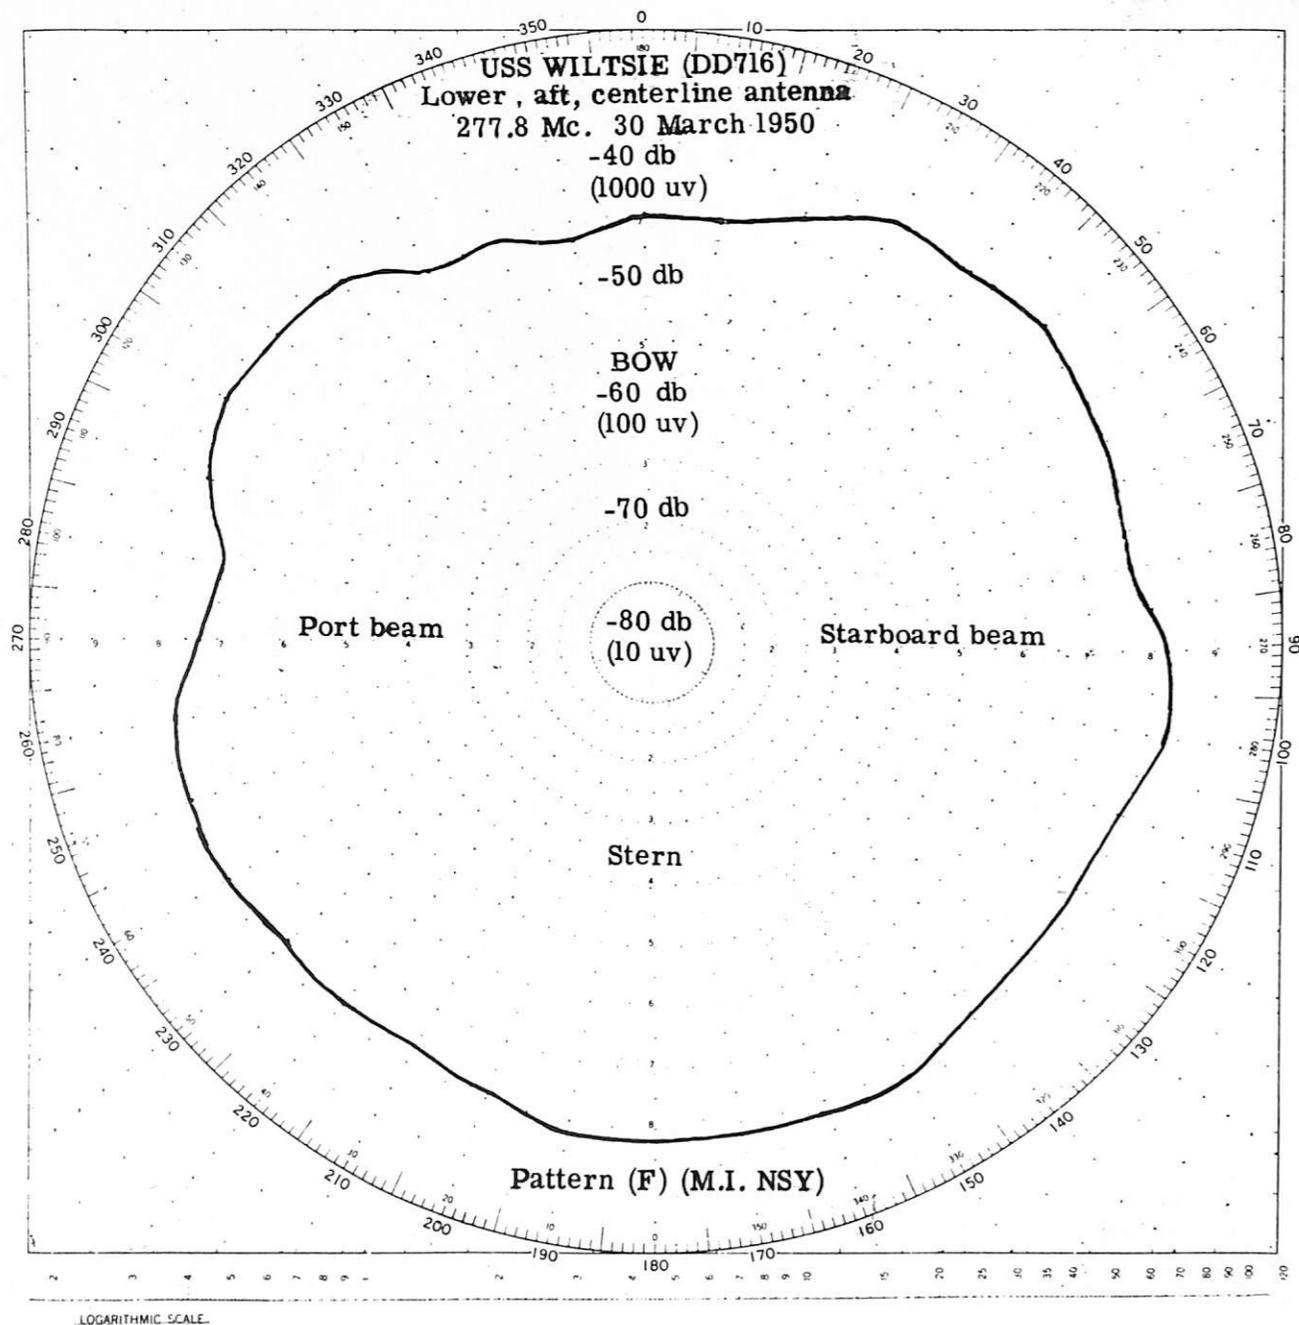
FIGURE 8—Antenna pattern from the *USS Wiltsie (DD-716)*, lower, aft centerline antenna, 277.8 Mc.

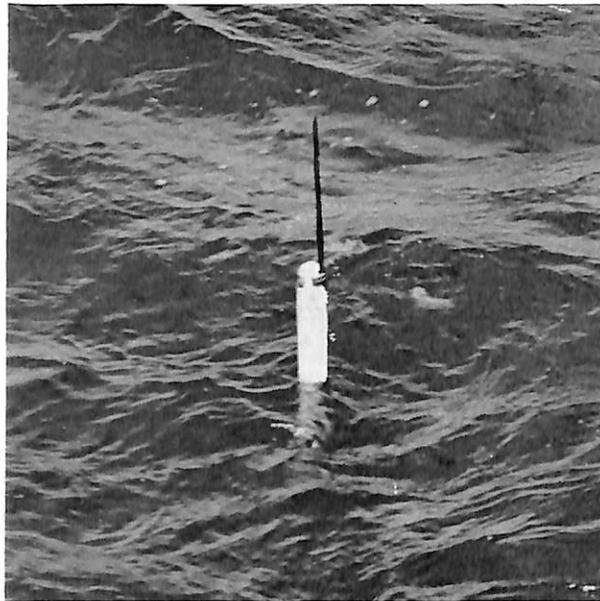
XDM in upright position.

As shown by Figures 1, 2, and 3, the buoyancy of the units was sufficient to bring them to the surface and permit them to float in a vertical position with about 4 to 6 inches of the case projecting out of the water. The units remained vertical in calm water but in the more turbulent sea states encountered in the tests, wind and sea at times tilted the buoys as much as 60° from

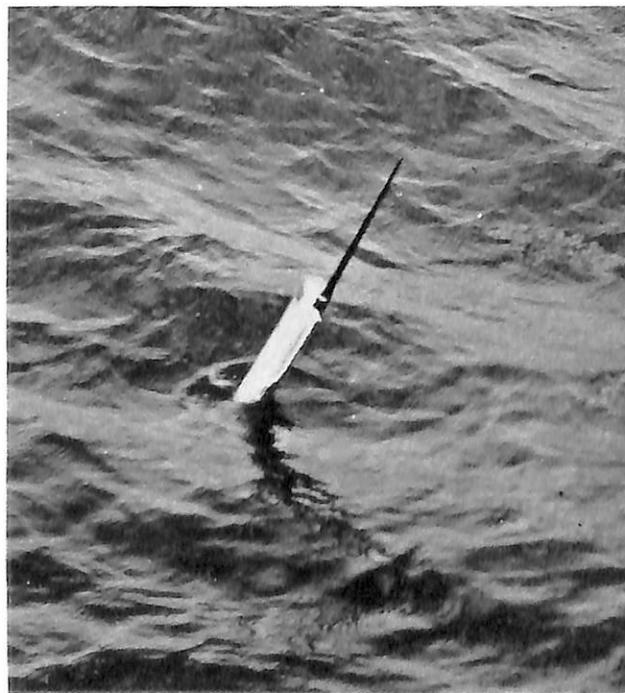
XDM starting movement to right.

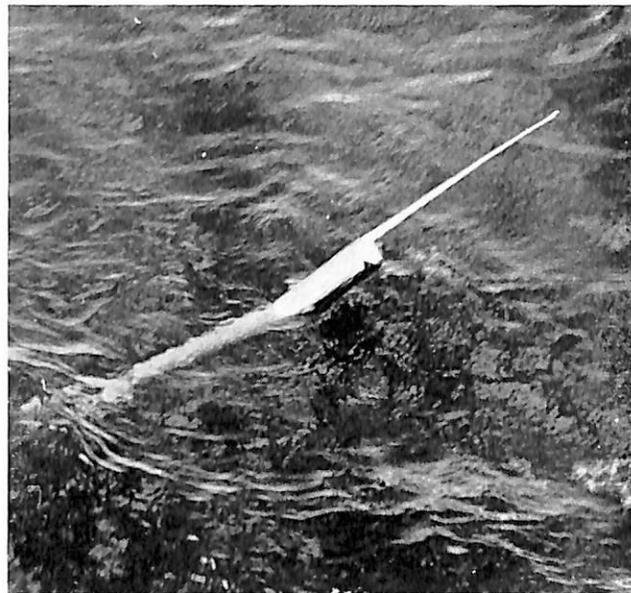
XDM at extreme angle to right.

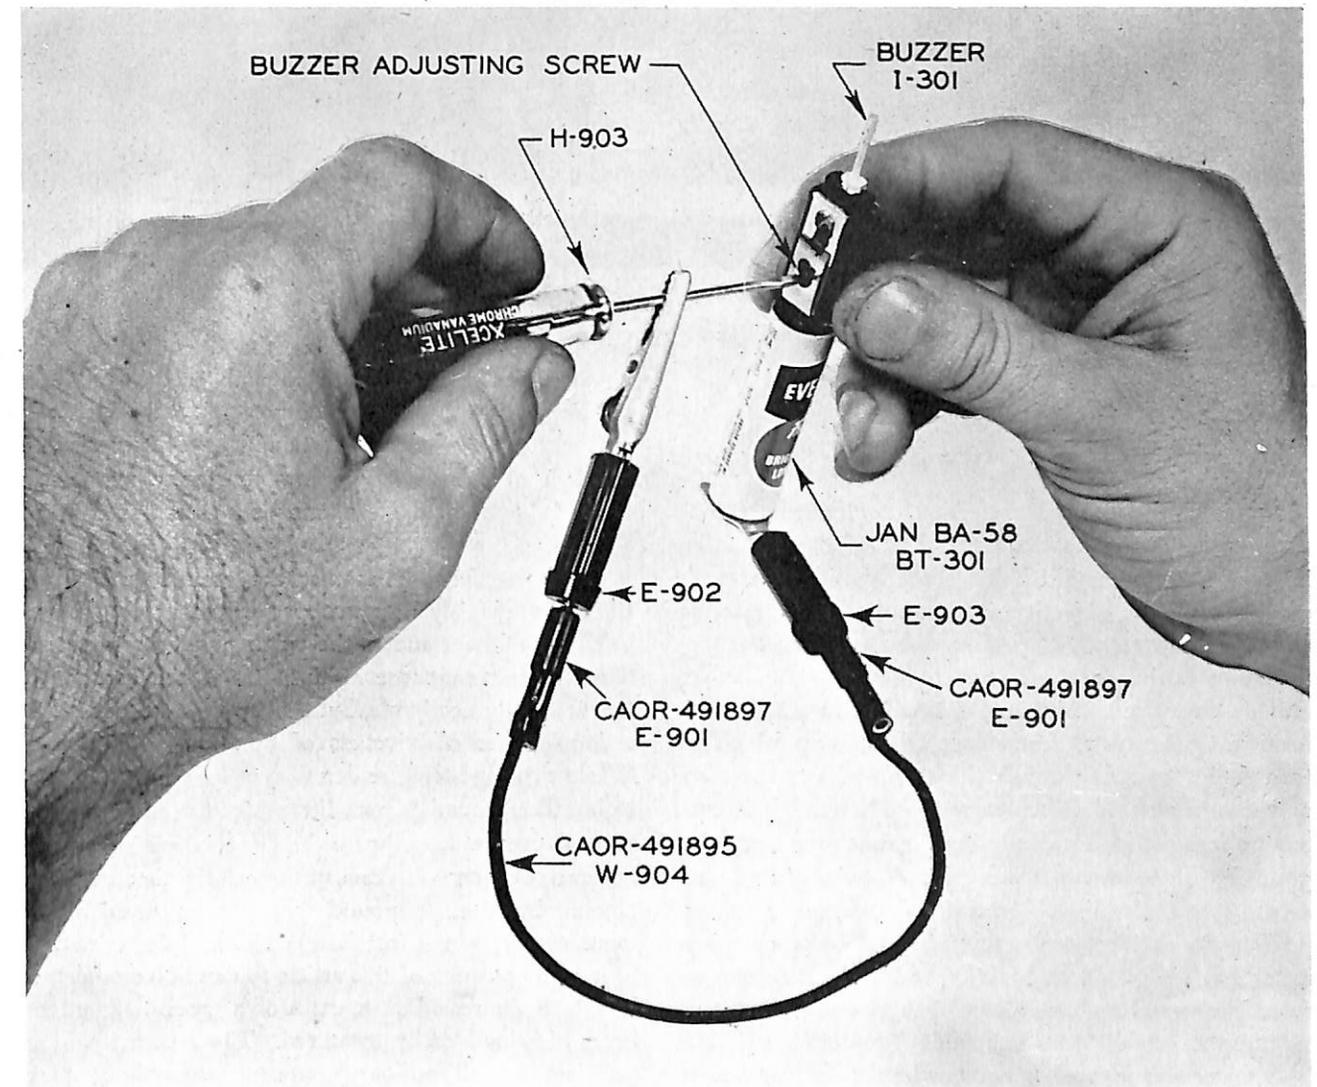
FIGURE 1—Buzzer adjustment for Interference Generator SG-23/U.

tration shows the equipment used and a convenient method for making the adjustment. With this method the buzzer is energized through the screwdriver and the battery terminal and will buzz when the adjusting screw is turned to the correct setting.

**CAUTION:** Pressure against the adjusting screw with the screw-driver bit will cause the buzzer to buzz at a false setting. Use very light touch with screw-driver.

ence Generator SG-23/U will not function when its BUZZER I-301 is out of adjustment. Readjustment of the buzzer can easily be made with AN/USM-3 test-tool set equipment. The accompanying illus-

ence Generator SG-23/U from this instruction book is reprinted below as Figure 1 together with a revised procedure for information. Only those noise generators which cannot be made operable when these instructions are followed should be forwarded to the contractor. If, however, a unit does not remain operative, but requires constant readjustment, it should be forwarded as a unit

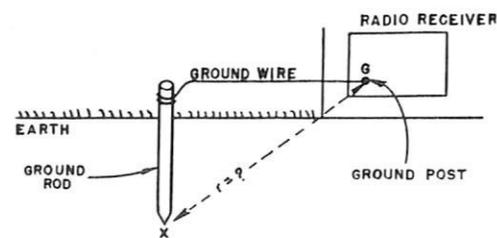
FIGURE 1

Figure 1 shows a simple ground system for a radio receiver. If we were able to connect an ohmmeter between the bottom end of the ground rod at point "x" and the ground post "G" at the receiver, we would measure only the circuit resistance of the rod plus the ground wire. The indication would ordinarily be less than one ohm. Since conventional grounds range in value from ten to five-hundred ohms, it is obvious that the circuit of Figure 1 shows only a portion of the overall ground system.

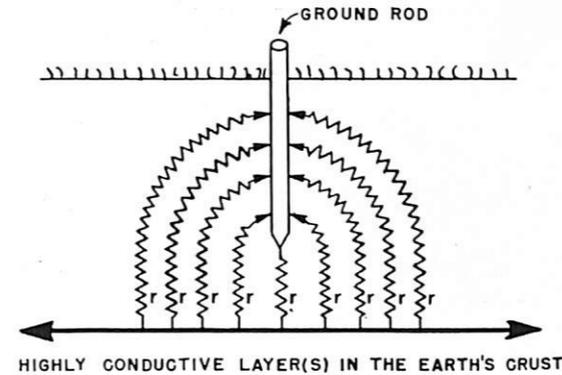
FIGURE 2

Figure 2 will illustrate the fact that each and every portion of the surface of the ground rod is connected through a separate path to one or more highly conductive layers in the earth's crust. Each path will have its own value of resistance, "r". All of these paths are in parallel with each other, and the number of such paths is nearly infinite. Our problem consists of determining the joint resistance of a nearly infinite number of parallel resistors, each having an arbitrary and varying value of resistance. Skipping the more involved mathematics, it can be shown that the summation for an infinite number of such parallel paths would be numerically equal to zero. This is the value for ground resistance that we try to obtain in our ground system, zero. While this figure cannot be fully attained, it can be approached. Note that if the ground rod in Figure 2 is increased in length, or in diameter, or if more rods are driven and connected in parallel, the number of parallel paths to the true earth will be increased and the joint resistance of the system will more closely approach zero.

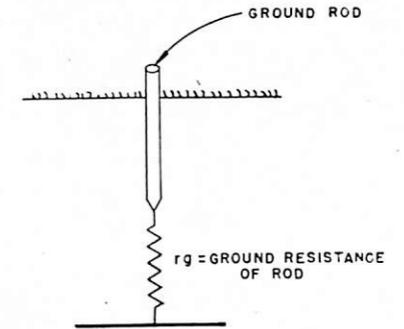
FIGURE 3

Now that we understand the problem more clearly it is possible to make certain assumptions which are entirely valid for the purpose at hand, and which will greatly simplify the matter. Let us assume that the joint resistance of all the possible earth paths from a single ground rod can be represented by a single resistor,  $r_g$ , connected from the bottom tip of the rod to a zero-resistance conductive layer in the earth, located some distance below the rod. The value in ohms of the resistor,  $r_g$ , is

the resistance to ground of the rod in question. This is represented by Figure 3.

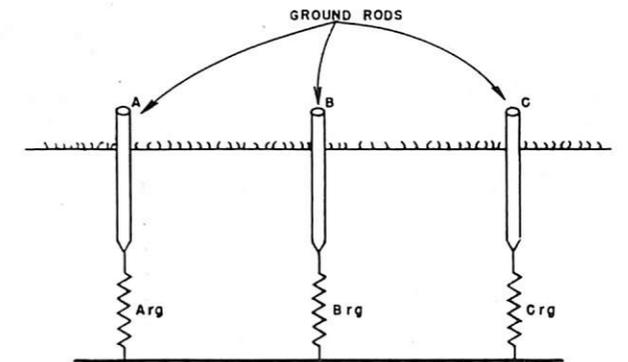
FIGURE 4

Any other ground rod may be similarly assumed to have its individual value of ground resistance, essentially unaffected by the presence of any additional rods, provided these other rods are placed a reasonable distance apart. This is illustrated by Figure 4.

For all practical purposes, the internal resistance of a rod having a diameter of one-half inch or more is negligible. Also, since one thousand feet of #10 copper wire has a resistance of about one ohm, it is apparent that a short and heavy ground lead between the equipment and the grounding system can have but negligible resistance. Thus our ground resistance is concentrated in the earth itself, and the additional circuit resistance of the rod and its connecting lead can be disregarded. We can now redraw Figure 4, leaving out unnecessary elements, as in Figure 5.

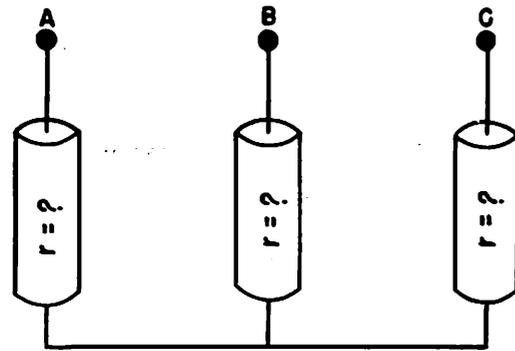
FIGURE 6

Figure 5 in turn may be pictorially shown as in Figure 6, where three unknown resistors are strapped together at one end. If these resistors were placed on a test bench and a technician were provided with an ohmmeter, he could determine the value of each resistance simply by

connecting his meter to the terminals marked A, B and C. By reading the values for different combinations he could easily determine the resistance of any one unit. Let us see how this can be done.

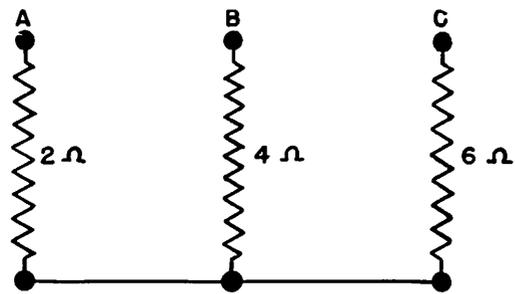
FIGURE 7

Assume three resistances of 2, 4 and 6 ohms connected

with one end common as in Figure 7. The resistance from A to B will total 6 ohms. B to C totals 10 ohms and A to C equals 8 ohms. The problem may now be solved by simple algebra, as follows:

The ground resistance of the master rod can now be found in the same manner used for solving the resistor network of Figure 7.

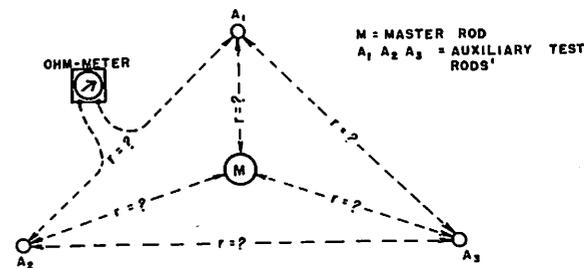
FIGURE 8

In exactly the same manner it is possible to measure the ground resistance of any water pipe or ground rod system. Let us proceed to determine the ground resistance of a single rod. It will first be necessary to drive at least two and preferably three auxiliary test rods. These rods should be placed in a roughly symmetrical disposition around the master rod. Two test

leads made of #14 insulated wire, terminated with heavy clips, will be needed to connect in sequence each two rods to an ohmmeter, as in Figure 8. The series resist-

ance of each pair of rods will be measured and recorded as in Table 1.

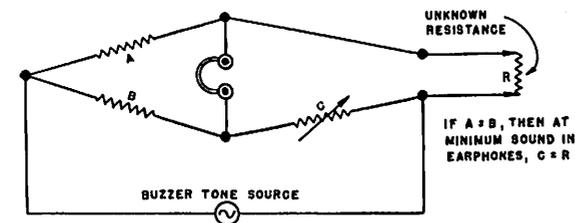
FIGURE 9

In some locations the use of the d-c ohmmeter becomes unsuitable because of large d-c or a-c components in the earth currents. For such cases the measurements can be readily made by using a Wheatstone Bridge excited by a tone source of several hundred cycles or more and balancing the bridge for the lowest or null indication in a telephone headset indicator. This arrangement is

shown in Figure 9. If a Wheatstone Bridge is not available, an acceptable substitute can be improvised by using two exactly equal resistors of about 1,000 ohms for legs A and B shown in Figure 9. A rheostat or pot having a range from zero to one hundred ohms can be substituted for bridge arm C, and the amount of resistance cut in by the rheostat at the point of balance determined by a subsequent ohmmeter test. When the null indication is achieved the bridge is balanced, and C is equal to the unknown resistance R.

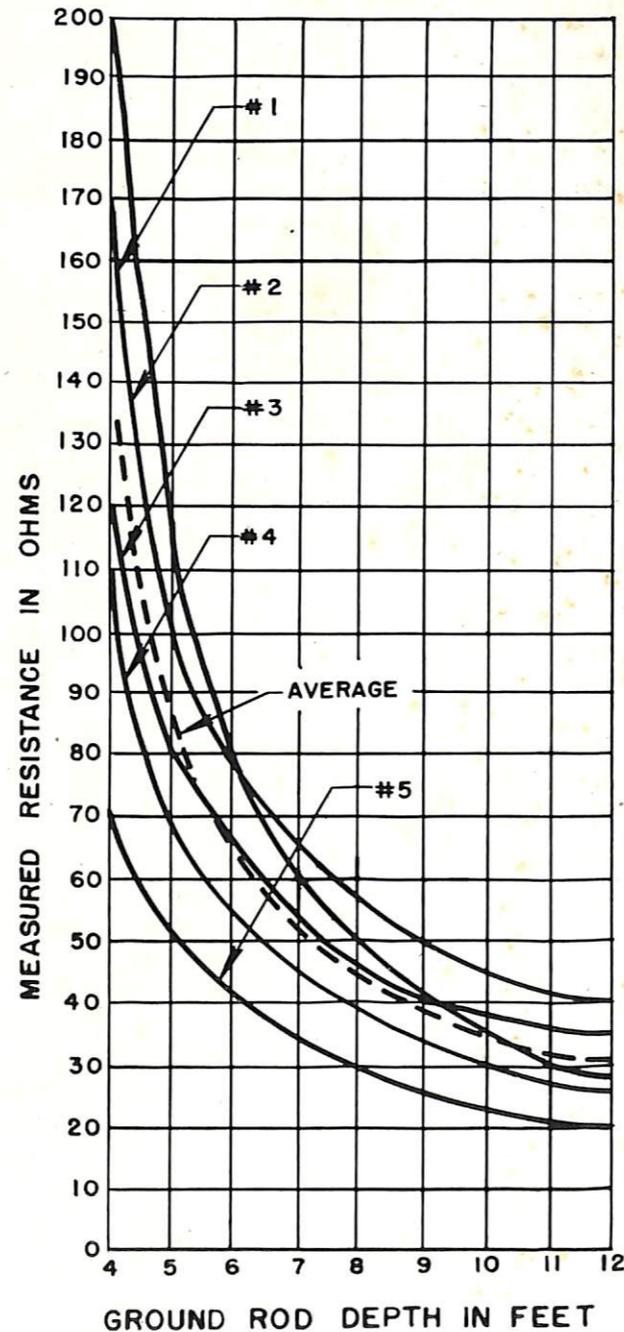
FIGURE 10

Since the variation of ground resistance with rod depth is of interest, the actual values measured are tabulated in Table 2 and plotted in Figure 10. The variation in resistance as the different rods were driven to various depths is shown in Table 3.

## GROUND RESISTANCE VS ROD DEPTH

It will be noted from Figure 10 and Table 3 that there was a wide range in the values measured for different rods at identical depths. This variation was most evident at shallow levels and decreased as the rods were driven deeper into the earth. At a six-foot depth the rate of decrease in resistance began to taper off. At ten

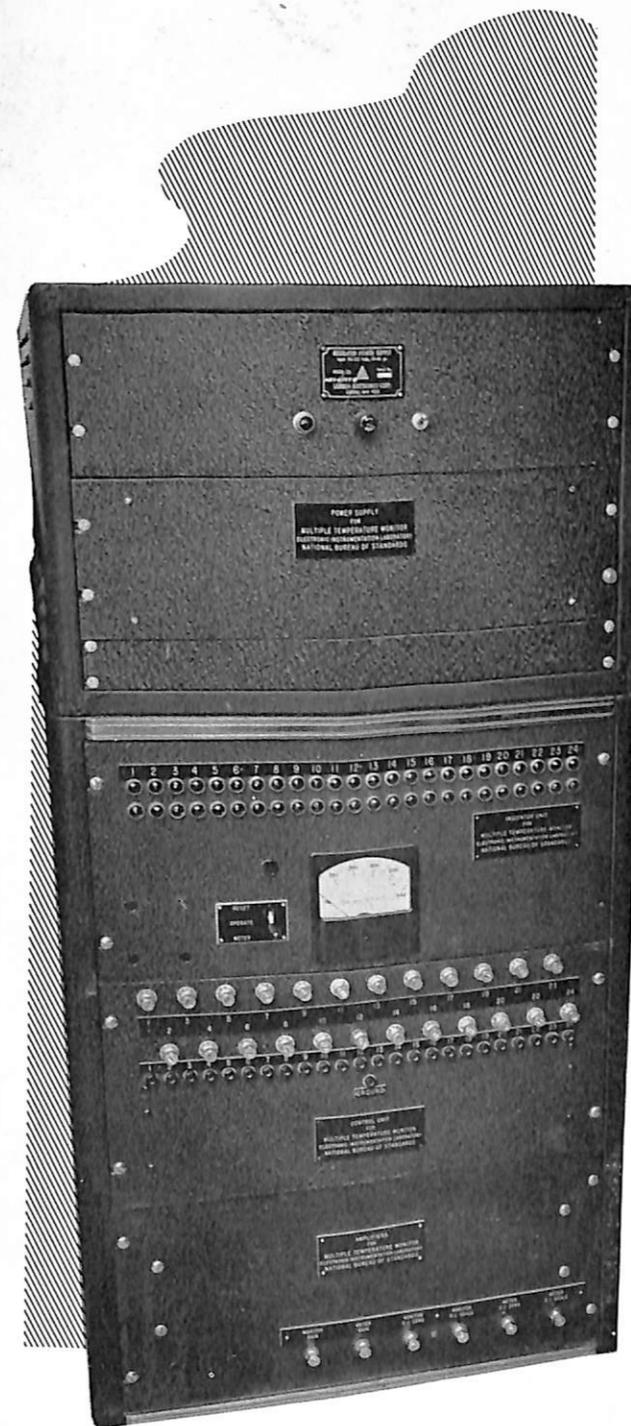
Front view of laboratory model of the multiple temperature monitor.

minimum. The switches are assembled in a circular frame and are actuated sequentially by a motor-driven cam. Since the scanning switch performs several other operations in addition to switching thermocouple inputs, the assembly actually consists of a stack of 3 levels. The first two levels are for switching each wire of the thermocouples (double-pole switching). These switch

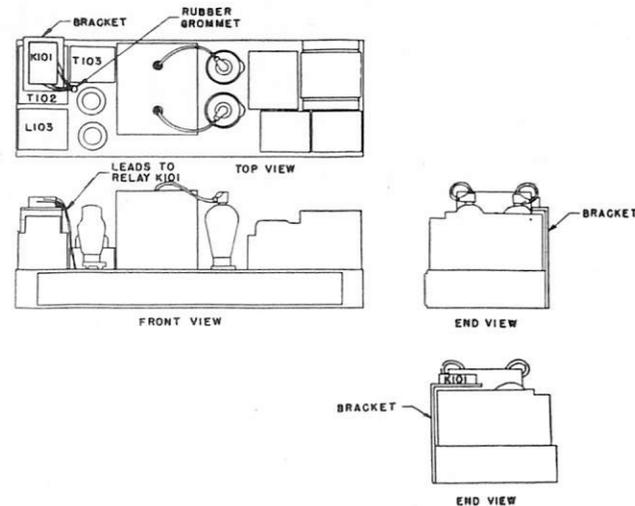
FIGURE 1

Presently this relay is mounted on the underside of the chassis which renders it extremely difficult to maintain and inspect. Mounting this relay on the upper side of the chassis as shown in Figure 1 will effect a saving of time and personnel in the maintenance and repair of this unit. The modification requires construction and installation of a simple angle bracket, as shown in Figures

1 and 2. The leads to the relay may be brought up through a rubber grommet as shown in Figure 1. The modification may be performed by Navy Yard personnel using standard stock material. No special tools are required.

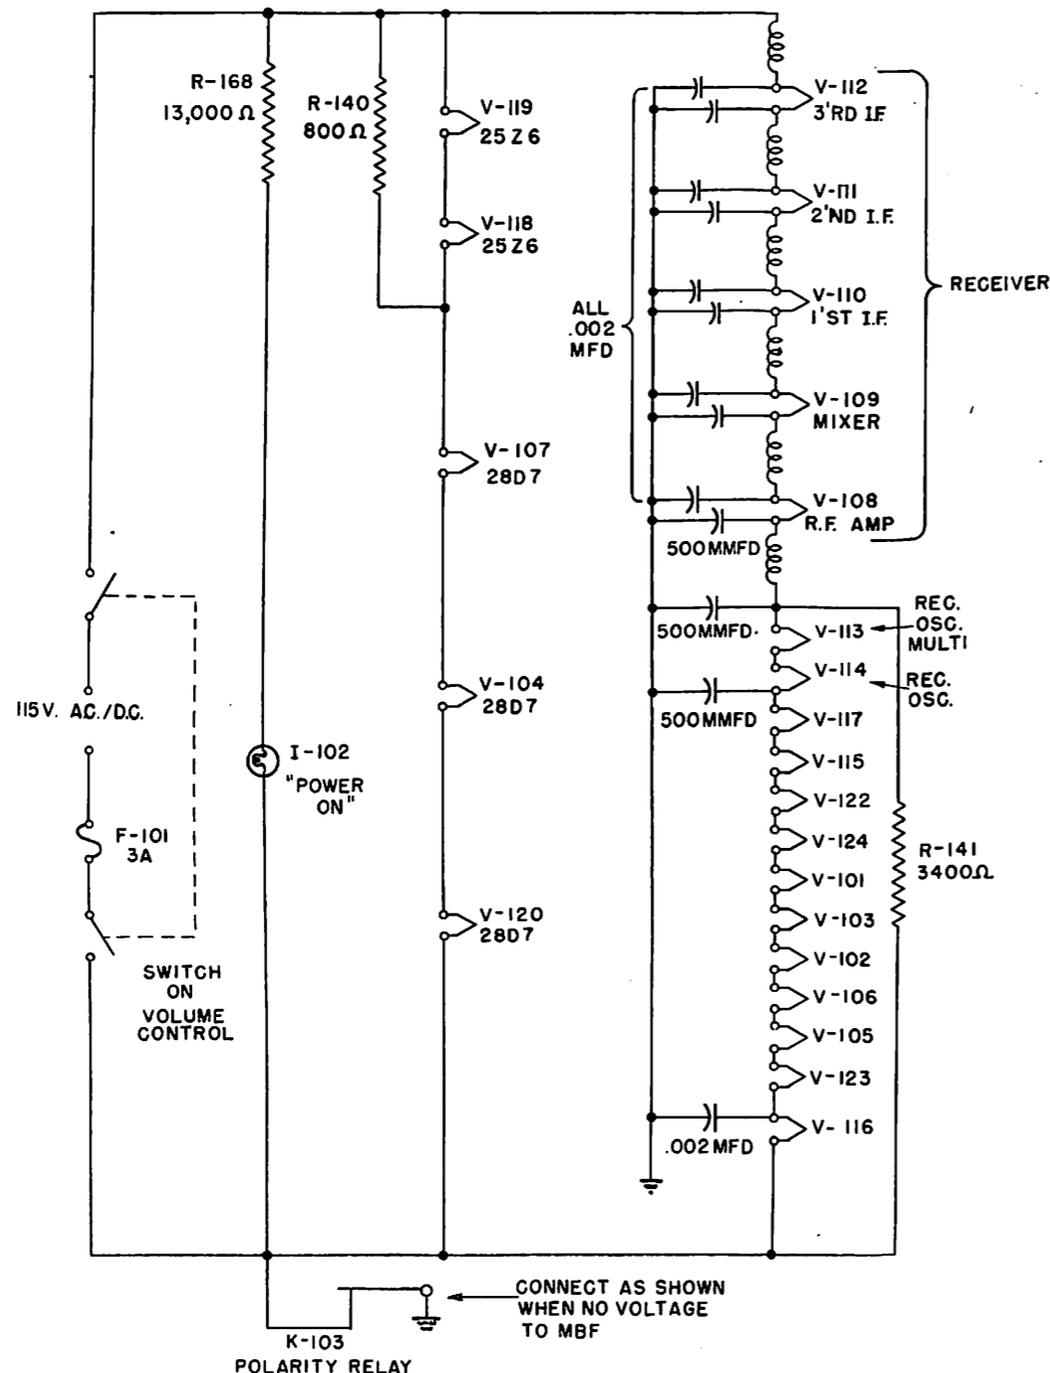
"Across the line" filament diagram for the Model MBF Radio Transmitting-Receiving equipment.
