Teletype Corporation Chicago, Illinois, U.S.A.

Specification 5779S Issue 2, Page 1 May, 1957

INSTRUCTIONS FOR INSTALLING AND ADJUSTING THE 152332 RELAY MOTOR CONTROL ASSEMBLY ON ELECTRICAL SERVICE UNIT LESU7 (BELL SYSTEM 28B)

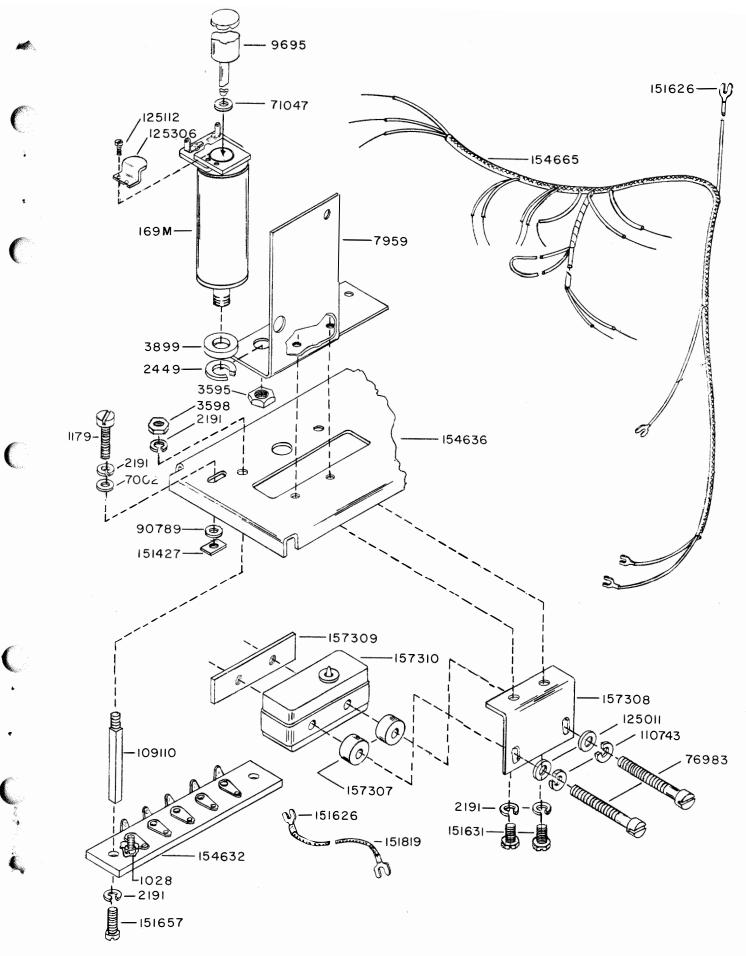
FIGURE 5-13. 152332 RELAY MOTOR CONTROL ASSEMBLY

*a. The 152332 Relay Motor Control Assembly consists of an aluminum plate approximately 2-3/4" x 4-13/16" to which are attached a solenoid, a single-pole double-throw enclosed switch, and a five screw connection terminal block. The solenoid is mounted above the plate and the switch is mounted under a slot in the plate. The terminal block is mounted in an inverted position on the under side of the plate. A cable with four spade type terminals provides for circuitry connections to the regular motor control and power terminal blocks already present in an LESU7 Electrical Service Unit. The assembly mounts in the extreme right hand position of the Electrical Service Unit, as viewed from the front of a printer set.

3. INSTALLATION (Figure 5-13)

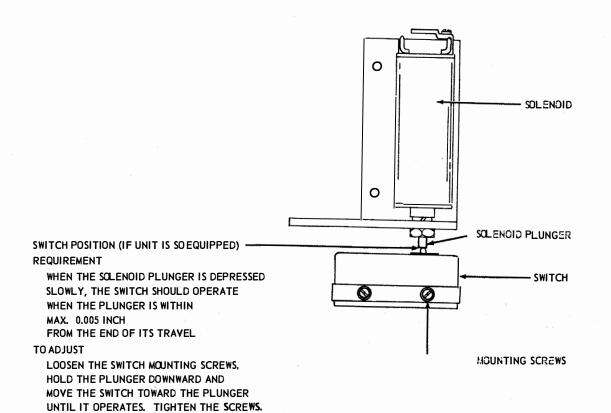
12. MOTOR CONTROL RELAY MECHANISM

FIGURE 136 ELECTRICAL SERVICE UNIT, MOTOR CONTROL RELAY

*4. ADJUSTMENTS (Figure 136)

Remake the adjustment shown in Figure 136.
